**Flood Control Project Maintenance
Levee Inspections****LMA District Cover Sheet****Spring 2014 Levee Inspection Results****Sutter Maintenance Yard Nelson Bend**

Spring 2014 Levee Inspection Results

Sutter Maintenance Yard Nelson Bend

Waterway			Bank	Unit Miles
Unit No. 01 Feather River West Levee-Nelson Bend				0.50
	Spring (March - May)	Summer (June - August)	(September - November) Fall	Winter (December - February)
Unit Maintenance Rating (Fall Only)				
Date of Inspection	05/01/2014 - 05/01/2014			
DWR Inspector	Matthew Hoffman			
Accompanied By

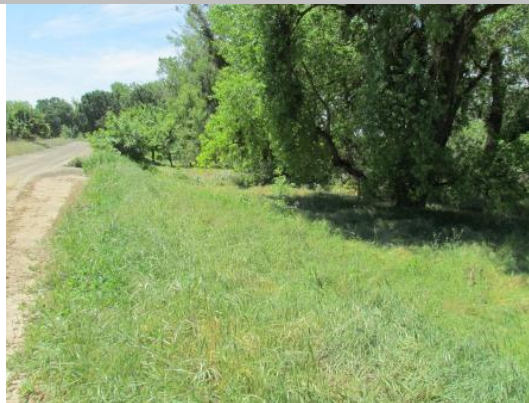
Photo 1 of 1 : mhoffman_s_20140502_501.jpg

LM Start	0.00	Rating **	M	Issue No.	2
LM End	0.19	Issue Type +	Ma	Location *	LS
Category	Earthen Levee			GPS Latitude/Longitude	
				Start	End
Item	Vegetation				° 38.884510 °
					° -121.615743 °
DWR ID	DWR_ST0006_01_s _ 2014_2				
Action/Comments					
Control annual grass and weeds on the levee slopes and easements.

This photo was taken from the crown facing south looking down the landward levee slope at vegetation requiring maintenance. Spring 2014.

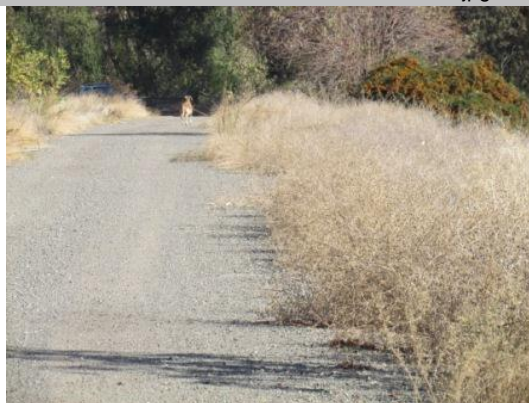
Photo 1 of 1 : mhoffman_s_20140401_291.jpg

LM Start	0.01	Rating **	M	Issue No.	1
LM End	0.45	Issue Type +	Ma	Location *	WS
Category	Earthen Levee			GPS Latitude/Longitude	
				Start	End
Item	Vegetation			38.886937 °	38.880822 °
				-121.614752 °	-121.614565 °
DWR ID	DWR_ST0006_01_s _ 2012_1				
Action/Comments					
Remove the wild growth other than native grasses from the levee slopes.

This photo was taken at levee mile 0.10 looking upstream at the waterward vegetation.

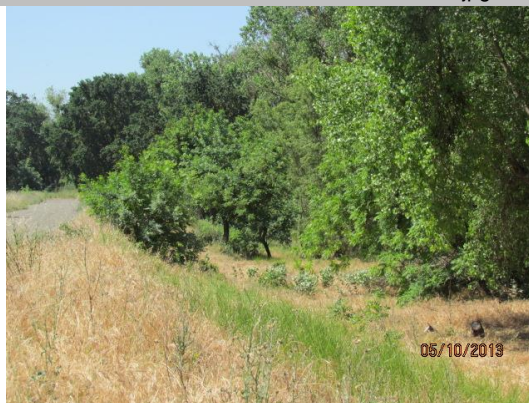
Photo 1 of 1 : mhoffman_s_20140401_292.jpg

LM Start	0.01	Rating **	M	Issue No.	3
LM End	0.45	Issue Type +	Ma	Location *	LS
Category	Earthen Levee			GPS Latitude/Longitude	
				Start	End
Item	Trim / Thin Trees			38.886933 °	38.880857 °
				-121.614753 °	-121.614555 °
DWR ID	DWR_ST0006_01_s _ 2012_3				
Action/Comments					
Thin trees to allow visibility of the ground and room to flood fight.

Trim the trees up 5 feet to allow visibility.

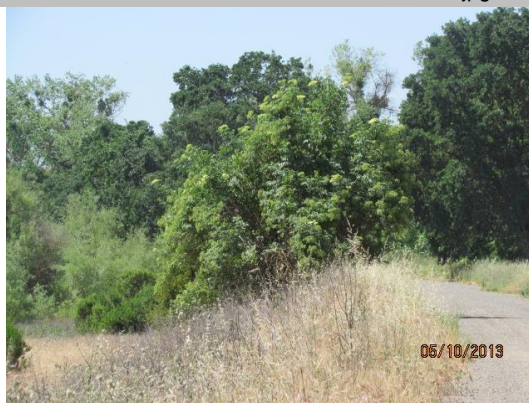
Photo 1 of 1 : mhoffman_s_20140401_293.jpg

LM Start	0.05	Rating **	M	Issue No.	4
LM End	0.05	Issue Type +	Ma	Location *	WS
Category	Earthen Levee			GPS Latitude/Longitude	
				Start	End
Item	Vegetation			38.886408 °	38.886408 °
				-121.615092 °	-121.615092 °
DWR ID	DWR_ST0006_01_s _ 2012_4				
Action/Comments					
Elderberries are blocking visibility and flood fight capability.

View of the elderberries that are blocking visibility.
